Manhole Inspection Summary

Manhole # S63A__002MH

Insp Date: **5/23/08 7:09 AM**

Location Address: **Lombard**

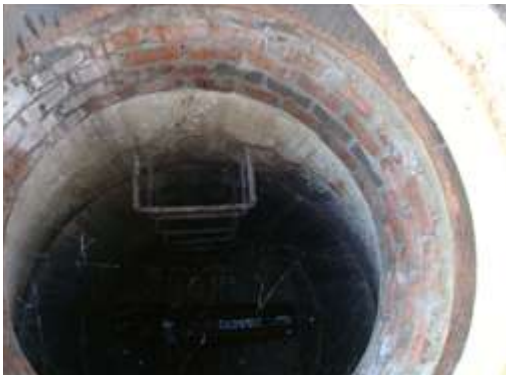
Defect 1

infiltration

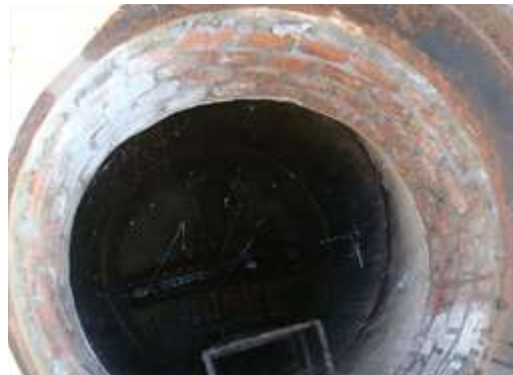
Defect 2

frame leaks

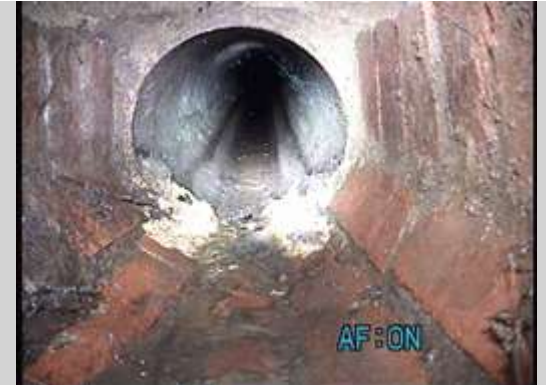
12 O'Clock Outflow

8 in. Circular Gravity Sewer
Pipe Out @ 12 O'Clock

Pipe Height: **8.4** (in.) Rod and Bar (Angled)
Pipe Material: **Clay** ☐ Pipe Lined
Invert Depth: **10.95** (ft.) Flow Characteristics: **Fast**
Deposits: ☒ None ☐ Mud ☐ Sludge ☐ Debris ☐ Grease
Silt Depth: (in.) Deposits Extent:
Infiltration: **None** Pipe Seal Cond: **Sound**

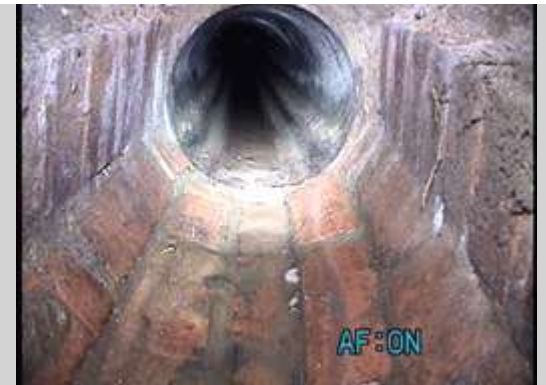
6 O'Clock Inflow

8 in. Circular Gravity Sewer
Pipe In @ 6 O'Clock

Pipe Height: **8.4** (in.) Rod and Bar (Angled)
Pipe Material: **Clay** ☐ Pipe Lined
Invert Depth: **10.60** (ft.) Flow Characteristics: **Fast**
Deposits: ☒ None ☐ Mud ☐ Sludge ☐ Debris ☐ Grease
Silt Depth: (in.) Deposits Extent:
Infiltration: **None** Pipe Seal Cond: **Sound**

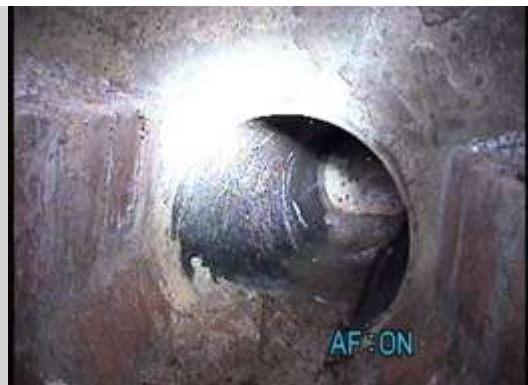
9 O'Clock Inflow

8 in. Circular Gravity Sewer
Pipe In @ 9 O'Clock

Invert Depth: **10.75** (ft.) Flow Characteristics: **None**

Infiltration: **None**

Pipe Seal Cond: **Sound**
